# TRAPPED BEHIND CLOSED SHUTTERS

## Fact Finding report

On the Amazon warehouse  
fire tragedy, Haldwani

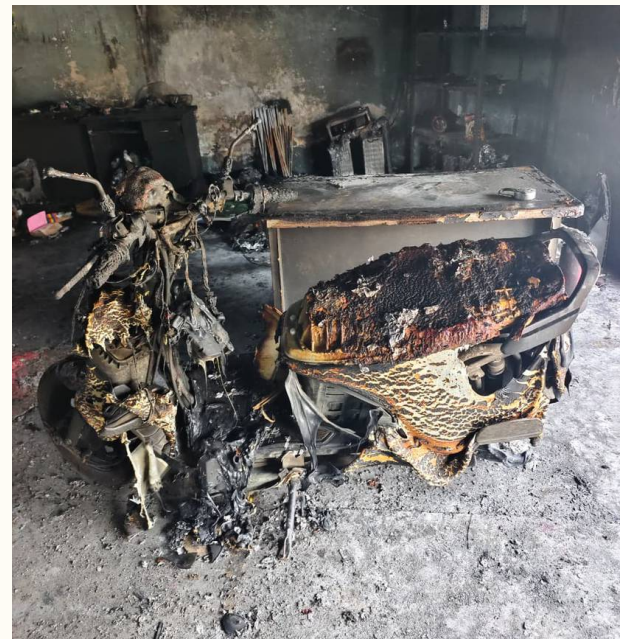
A severely burnt two-wheeler was found inside the warehouse premises. The vehicle had been reduced almost entirely to its metal frame, with complete destruction of its seat, wiring and plastic components. The presence of a delivery vehicle within the warehouse raises important questions regarding the storage of vehicles inside enclosed spaces, particularly during non-operational hours.

*Insides of the warehouse showing the burnt scooter which was parked inside.*

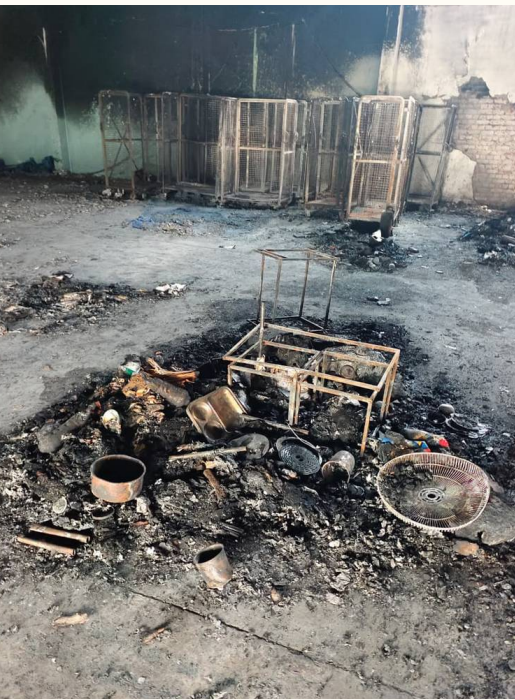
On 7 June 2026, the fact-finding team visited the warehouse located in Jeetpur Negi, Haldwani, Uttarakhand and the nearby area to enquire about the warehouse, status of the locality, and regulatory provisions and gaps. The site inspection revealed severe fire damage across the warehouse premises. The interior walls were heavily blackened with soot deposits extending up to the roof, indicating intense heat generation and widespread smoke accumulation. The corrugated metal roofing sheets and supporting steel trusses displayed visible signs of exposure to prolonged high temperatures.

*Walls of the Amazon warehouse covered with black soot and other burnt materials.*

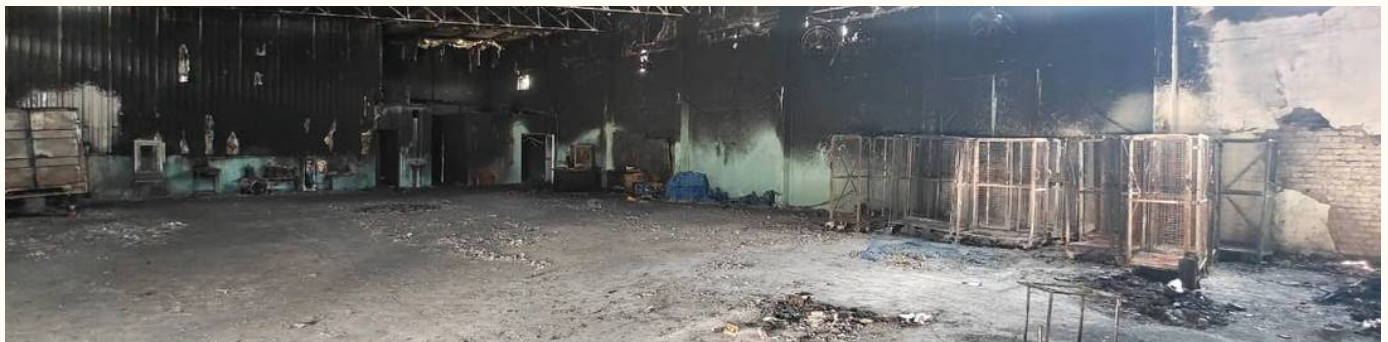
*Inner walls of the warehouse covered with black soot and other burnt materials.*

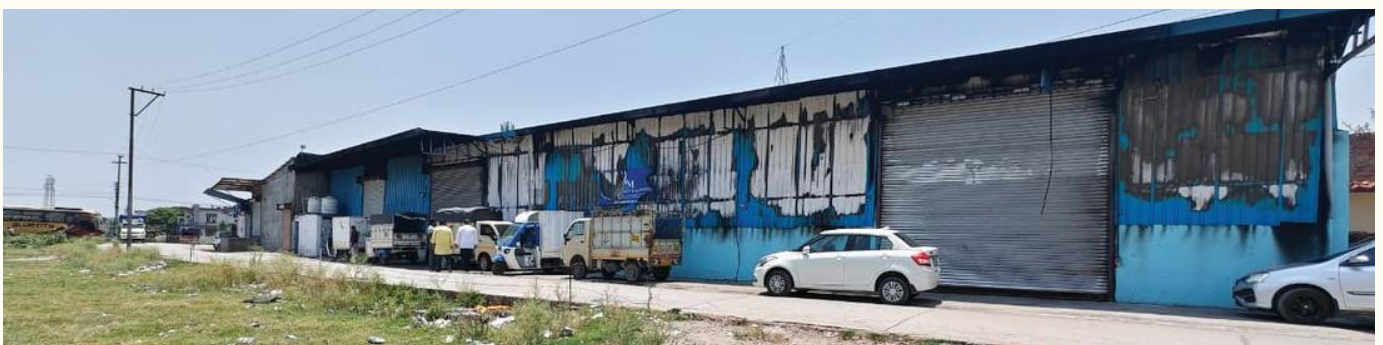
*Outside of the Amazon warehouse.*

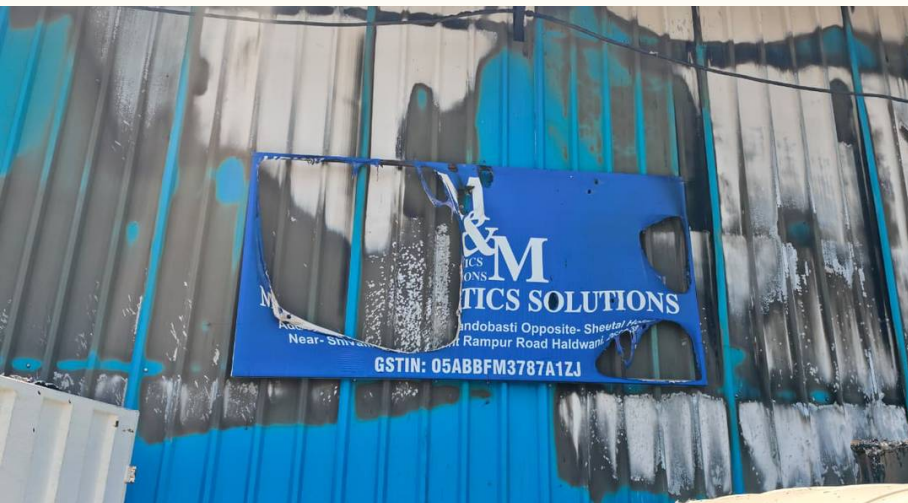
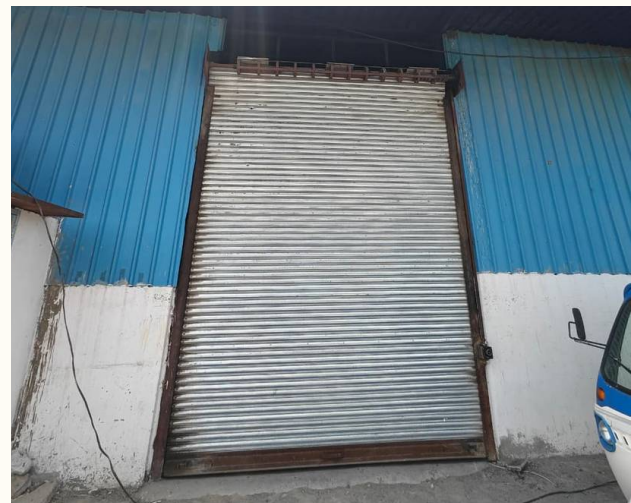
*Outside of the Amazon warehouse.*
